STREAMBANK & SLOPE STABILIZATION

Case Study

Project Name	Pipeline Slope Stability
Location	Versailles, Illinois
Date of Installation	June 2020
Contractor	Midwest Services Group
Salesperson	Ed Nelson

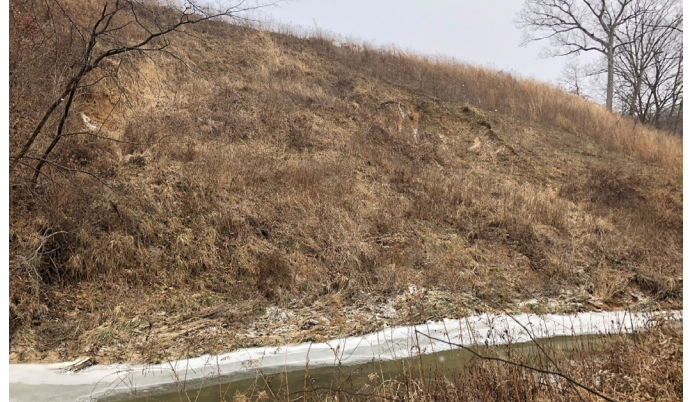
Image of the project site before intervention showing the slip surface of the slope within the pipeline ROW.

The contractor was faced with a steep slope along a natural streambank that failed. The slope was eroding and contaminating the stream with sediment. This slope was also in a pipeline's right-of-way (ROW) area. To ensure the safety of the pipeline and surrounding property, the slope needed a long-term, high-performance stabilization solution to correct the failing slope and prevent any issues in the future.

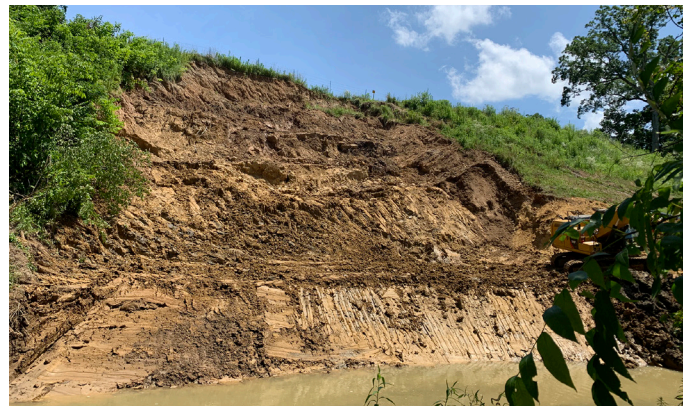
Removal of sloughed soil.

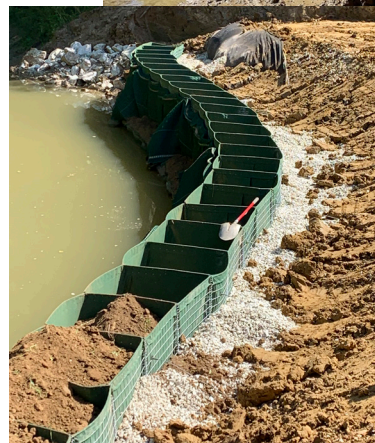
Installation of SCOURLOK complete. SCOURLOK filled with slope graded.

First row of SCOURLOK installed.

SCOURLOK was utilized to stabilize the toe of the slope at the creek bottom.

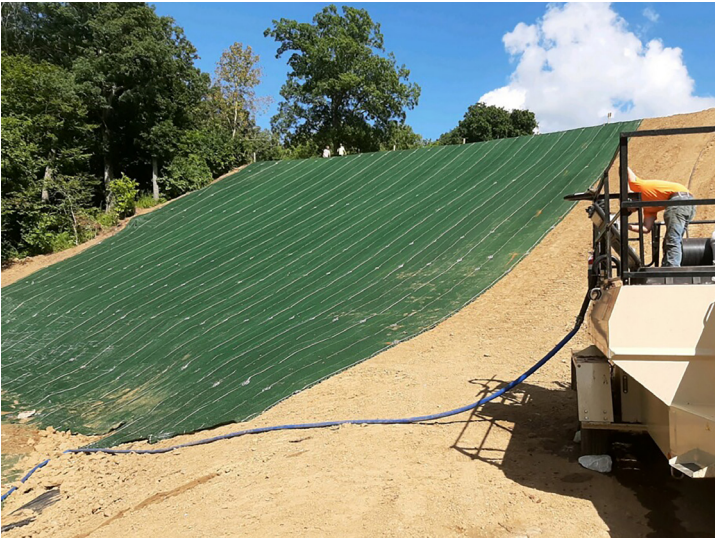
ARMORMAX Installation on Slope

To create a stable slope, **ARMORMAX** Engineered Earth Armoring System™ was utilized by combining High Performance Turf Reinforcement Mats (HPTRMs) and Engineered Earth Anchors™ (EEA) that work together to lock soil in place and protect against hydraulic stresses.

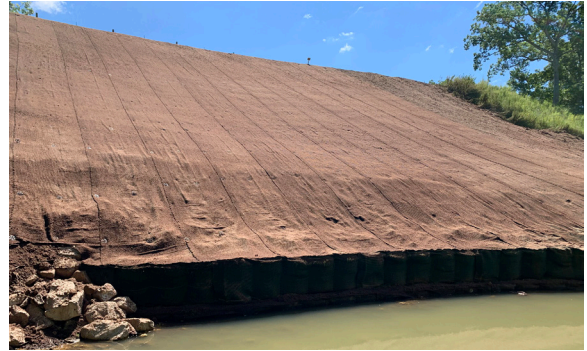
After ProGanics Installation

Next, two of Profile Products' products were recommended. To improve the likelihood of successful vegetation, **ProGanics Biotic Soil Media** was sprayed on top of the ARMORMAX and **Flexterra** flexible growth medium was the final "glue" to stabilize the slope surface, supply moisture support for the vegetation establishment, and ensure the seeding remained in place until root establishment is maintained.

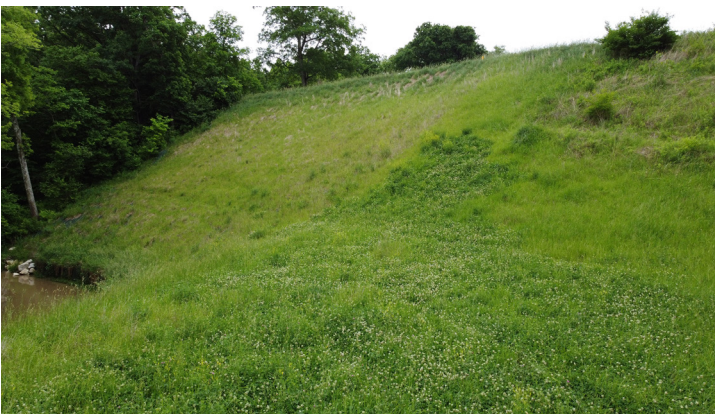
One year later the slope is fully vegetated and looks great.

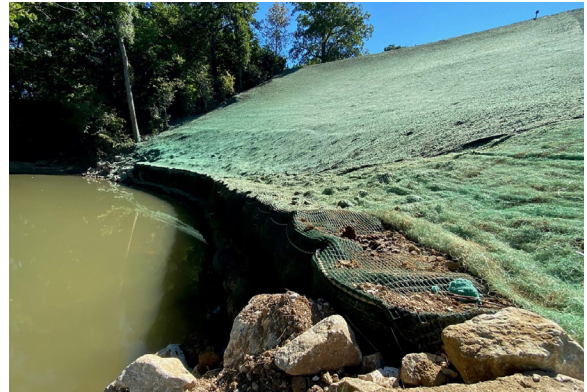
After Flexterra Installation
