# Case Study

Vol. # 3.03

## Geoweb Lake Edge Treatment

*Lake at  
Westport Plaza  
St. Louis, MO*

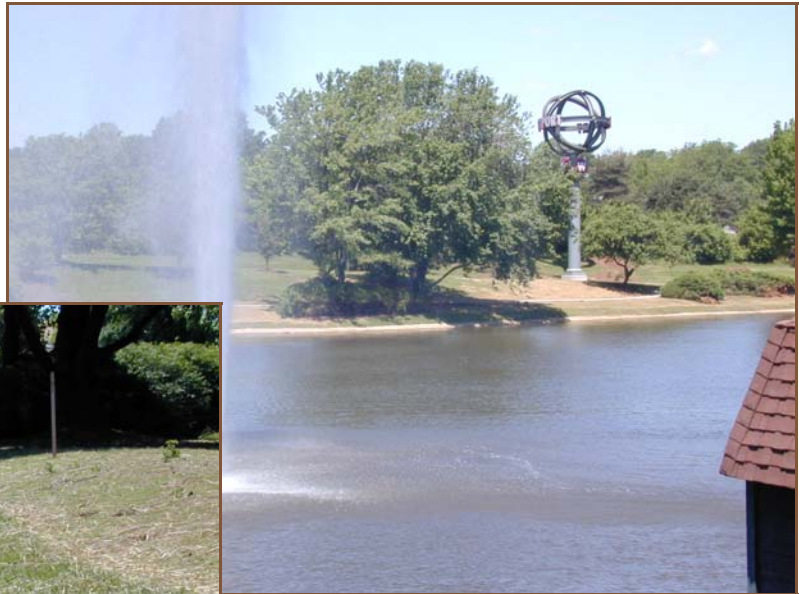
Installation is easy and fast. Concrete is placed in the bottom 5' of the Geoweb and soil with sod is placed in the top 3'. This provides 1' of concrete filled Geoweb above the water's surface.

Geoweb is used at this lake in Westport Plaza to provide erosion protection around the edge of the lake. Many people, and geese, like to walk down to the water's edge. Before the Geoweb installation, 2 attempts had been unsuccessful at providing a stable edge treatment to the lake. The Geoweb is the long term erosion solution to this project.
