Big Sandy Lake Levee Repair Case Study

Project: Clear Creek Levee Improvement

Location: Big Sandy Lake
North of Ashland, NE

Application/Solution:
Shoreline Stabilization

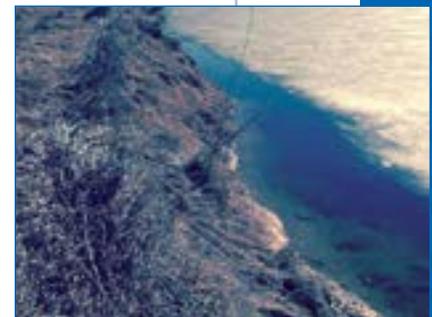
1 Here is one example of the eroded, near vertical banks.

A presentation on Flexamat, a tied concrete block erosion mat, was completed for the United States Army Corp of Engineers (USACE) and follow-up discussions lead to it being proposed in lieu of large rock riprap for the lakeside face of the levee. With design assistance from the product's manufacturer, the USACE specified approximately 141,000 sq. ft. of Flexamat as one of two proposed articulating concrete mat bid items. A separate layer of an 11 oz. non-woven filter fabric was called out for to control potential migration of the underlying sandy soils. The USACE also decided on covering/infilling the mat with soil and a single-net straw erosion control mat assuring a rapid and aesthetically pleasant "greening-up" of the site.

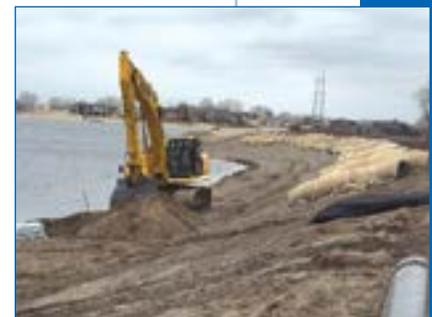
2 Flexamat staged for installation.

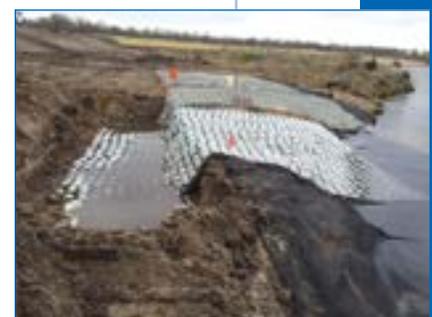
3 A very strong anchor trench was incorporated in the design.

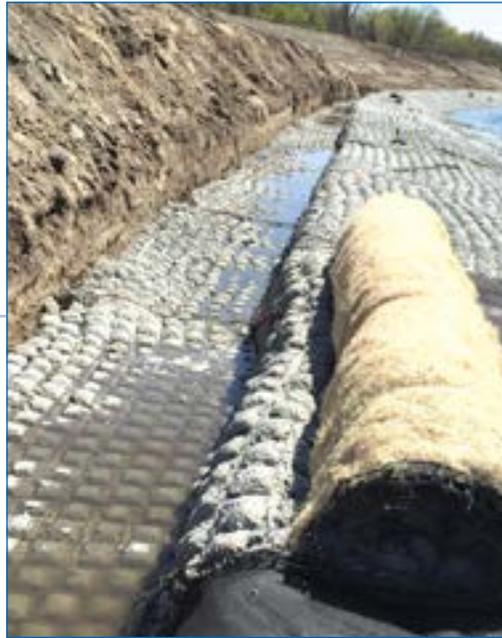
4 Flexamat in the anchor trench and ready to be deployed into the water.

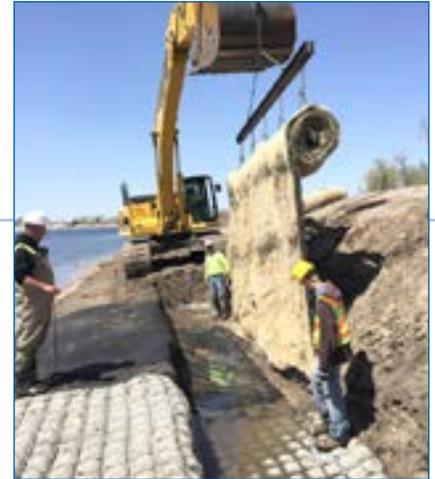
5 Simple equipment can be used to install Flexamat.

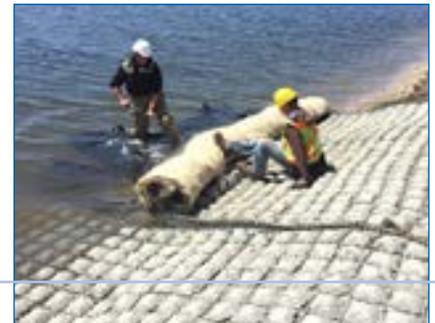
6 Here is one way to roll it out.

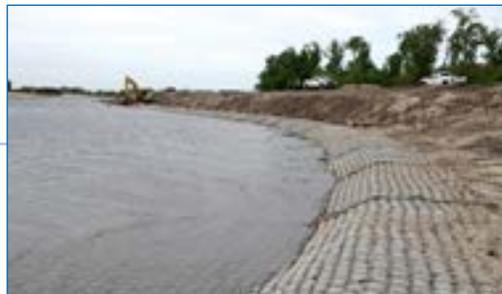
7 Flexamat is installed quickly.
