# Fontanelle Forest Channel Restoration Case Study

Project: Fontanelle Forest Channel Restoration

Application/Solution: Installing topsoil filled Presto GeoSystems' GeoWeb with North American Green's C350 Turf Reinforcement Matting as well as S150 Straw Mat

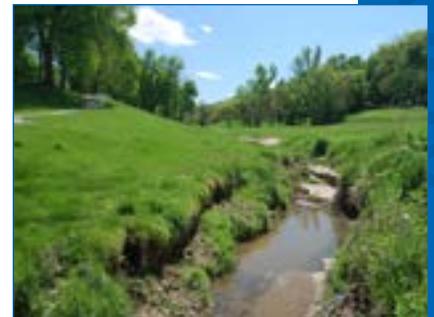
Forest property runs through steep bluffs adjacent to Missouri River in Eastern Nebraska and is in the middle of various residential developments. More than 20 years ago, a suitable solution would have been to line waterways with concrete and await the inevitable water flow damage. Severe undercutting and deterioration along with dense overgrowth of the concrete over the last 2-3 decades created ravines. Similar repairs were needed for the Fontanelle Hills Golf Course.

1 Overgrowth and undercutting before repairs at golf course.

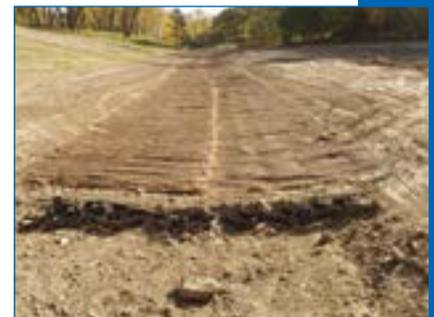
2 Primary stages of grading and installation.

One golf course owner visited ASP Enterprises in Omaha and was introduced to and became enamored with the vegetated solution offered by the combination of a cellular confinement system and a turf reinforcement matting. The project became a priority for new property owners, who applied with NE Environmental Trust Fund for grants for these critical repairs. The City of Omaha, City of Bellevue, Papio MO River Natural Resource District, the Corp of Engineers and volunteers also participated financially. The overall funding for the project exceeded \$1 million. Contractor superintendent, Dana Jorgensen, along with ASP's Lynn Ewoldt and Gary Garabrandt made the final decision to use the soft armor system. Through 2011 and 2012, grading and various stormwater work was completed. This work was completed in drought conditions followed by an abundance of rain in Spring 2013 and thus, created difficult conditions for vegetation growth. Volunteers, 2 part-time and 2 full-time employees made the installation.

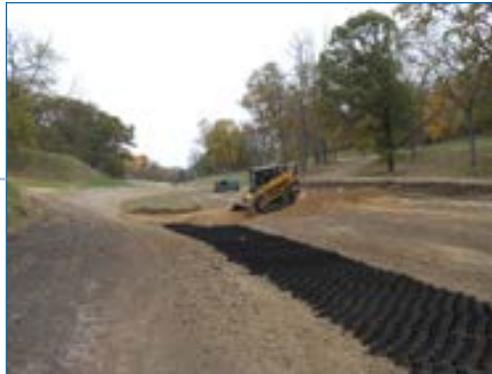
3 Presto GeoWeb installation.

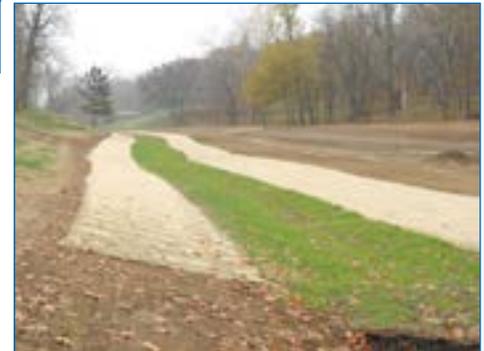
4 Turf Reinforcement Matting installation.

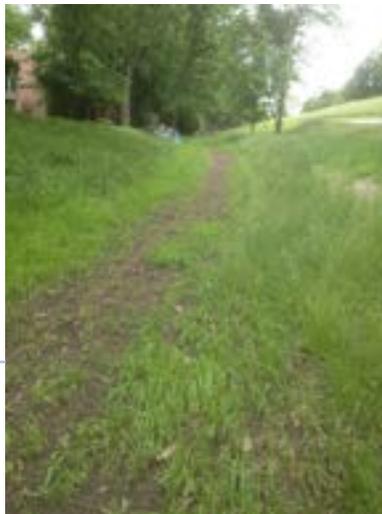
Because of severe weather conditions, minor repair work was necessary to restore drowned vegetation. It has since fully vegetated and Gary Garabrandt believes the project leaves behind a low maintenance and permanent solution, along with a proud legacy as he prepares to retire at the end of the year.

5 Vegetation growing through solution.
