# Verdigre Slides Reinforced Slope Case Study

Project: Verdigre East & South Slides

Location: Verdigre, Nebraska

Application/Solution: Using Geogrids to repair Slope Failure

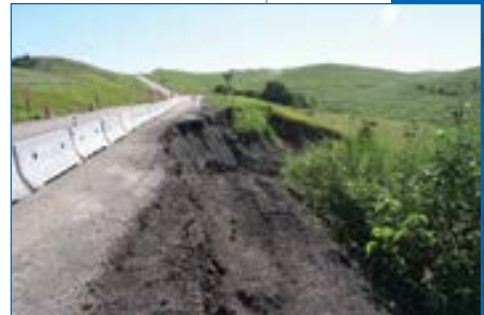
1 Photo Verdigre east slide pre repair.

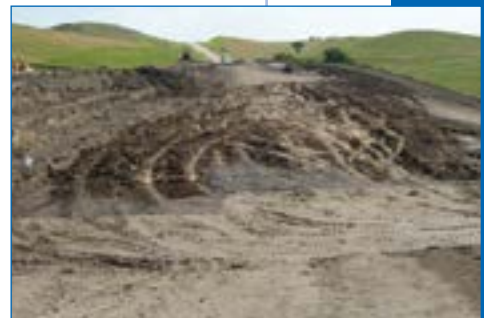
2 East slide construction.

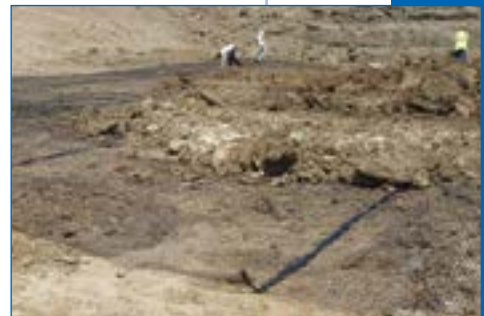
3 No overlapping of geogrid required.

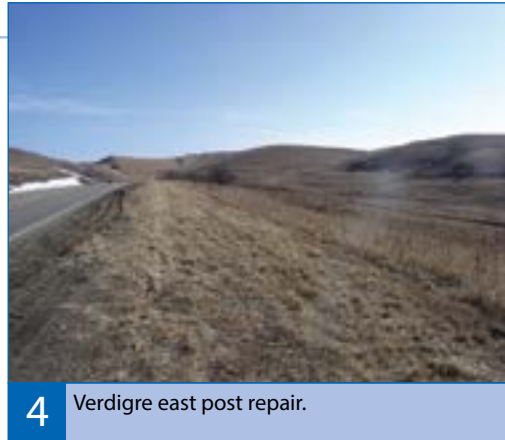
4 Verdigre east post repair.

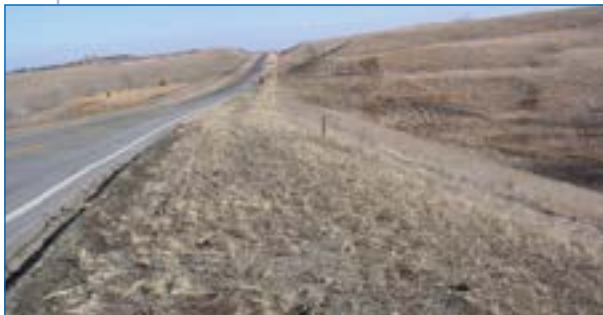
7 Highway restored to original condition.

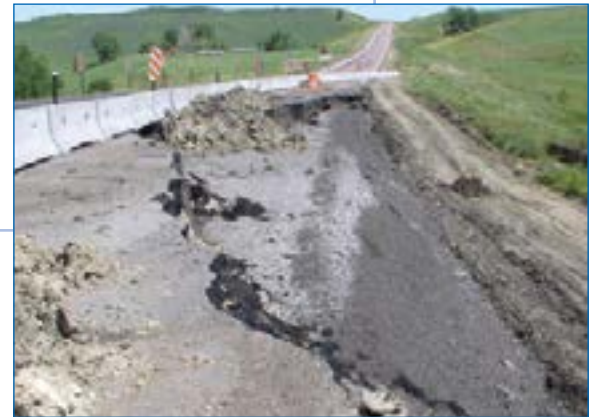
The NDOR has been dealing with repairing slide areas in northeast Nebraska since the 1960's. In this area of the state, there are many different soil layers on top of one another. When these layers become saturated, due to years of rain events or natural springs, they act as a slip plane and start to slide. It is these slide areas that become dangerous to traffic and need to get taken care of immediately.

6 Saturated soils cause slope failure.
