# Walker Lake and Monroe Creek Erosion Control Case Study

Project: Walker Lake and Monroe Creek  
Location: Kirkwood, MO  
Application/Solution: Coir logs were installed and planted with plant plugs to vegetate  
Owner: City of Kirkwood  
Salesperson: Mark Stirnaman  
Contractor: City of Kirkwood (Walker Lake)

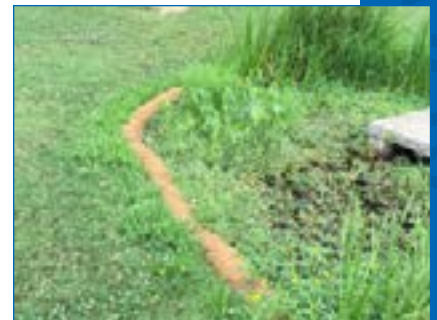
1 Coir log surrounding Walker Lake.

Coir logs anchored with wooden stakes solved Walker Lake's erosion issue. After installation, the coir logs were planted with the desired plant plugs. Monroe Creek used coir logs as toe protection to create a smooth transition from the rocky bottom to the vegetated side slopes. Above the coir logs the slopes were graded and covered with seed and a temporary erosion control blanket. Similar to the Walker Lake project, these coir logs were also fixed with desired plant plugs to increase channel vegetation.

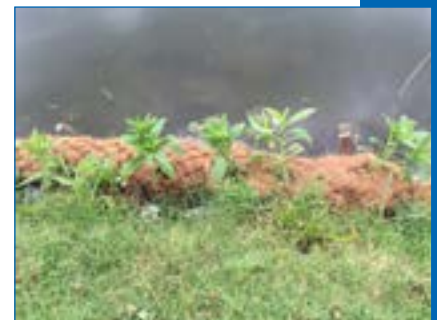
2 Coir fiber log with vegetation growth.

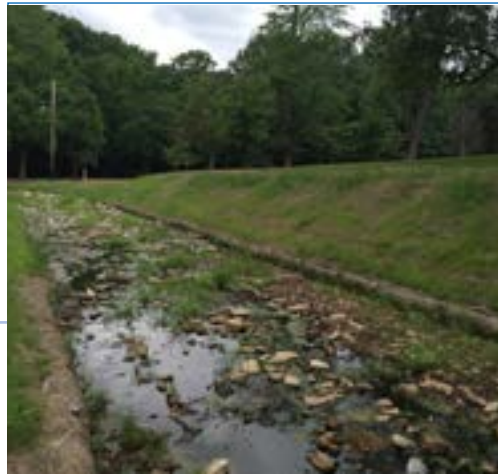
3 Coir fiber logs in place at Monroe Creek.
